Rundschreiben der Abteilung Kundendienst und Teile

Motorcycles: Group Rear Wheel Drive No. 1/62 (183) engl.

Drive shafts BMW R 25/3 - R 26 - R 27

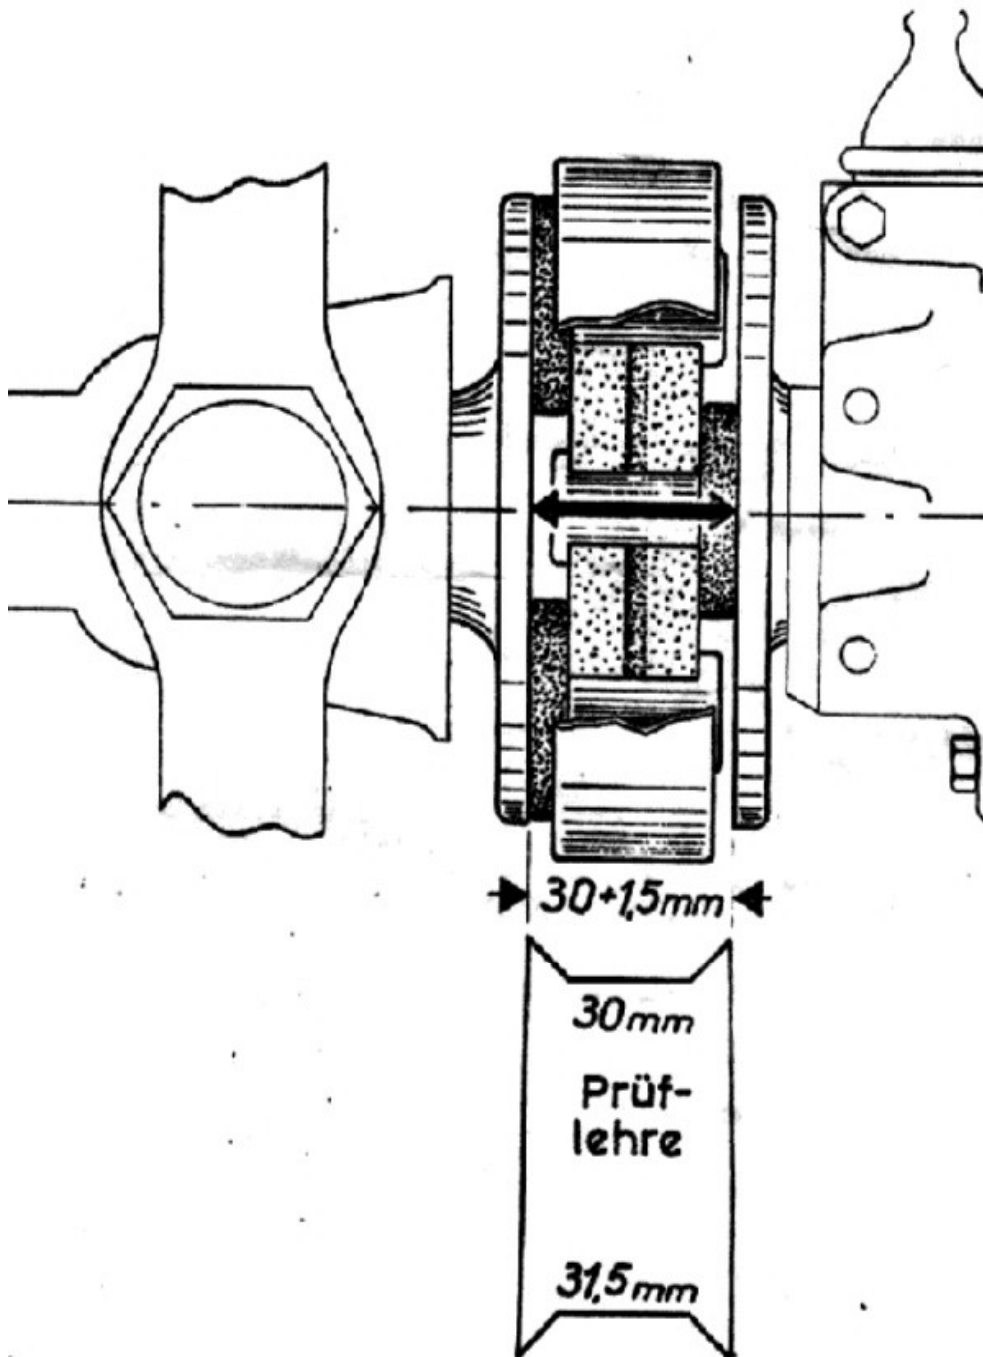
Enclosure  
Drawings

Occasionally we are receiving reports concerning drive shaft breakages on the motorcycle models referred to above.

the distance between the driving flange of the transmission and the mating flange of the drive shaft, measured with the drive shaft in horizontal position, amounts to 30 + 1.5 mm. (1.2" + .06").

To check and adjust this distance we suggest that a checking gauge be made of a 3-4 mm. (.12" to .16") thick flat iron as per enclosed drawing. To prevent further damages, the above mentioned distance must, whenever a repair work has been carried out on the bevel drive or on the drive shaft itself, absolutely be checked and, if necessary, adjusted, loading the motorcycle for this so the drive shaft is in horizontal position and that the two flanges are thus parallel.

The necessary corrections, if any, should be performed,

on the R 25/3 type, by pressing the coupling flange up or downwards,

on the models R 26 and R 27 by means of spacing washers (shims).
